LONG TERM PERFORMANCE OF
THREE BRIDGES ON PERMAFROST

FINAL REPORT

Dean Baldassari
Research Engineer

September 1985

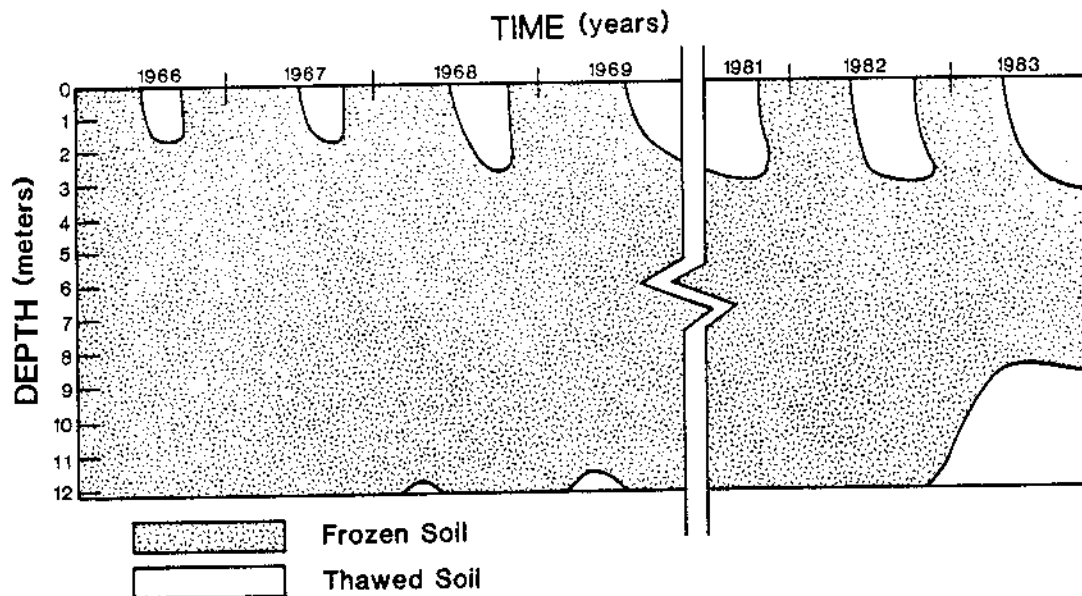
FIGURE 3: DEGRADATION OF PERMAFROST OVER TIME AT PILE 1,
ABUTMENT 1 OF THE GOLDSTREAM CREEK BRIDGE

The changes in frozen and thawed zones, as determined from periodic temperature readings along one of the piles supporting Abutment 1 show a degenerative permafrost condition over the past seventeen years (Figure 3). This condition was first noted by Crory in 1968. "The temperature in the middle and bottom sections of the pile length in permafrost is only about 31.2°F" (-0.44°C). "In addition to the warm permafrost temperature, the negative gradient (decreasing temperature with increasing depth below about 10 ft" (3m) "suggests a degenerative or warming permafrost trend." At the time of construction, Pile 1 of Abutment 1 was imbedded in approximately 33 ft (10 m) of permafrost. Presently only about 16 ft (5 m) of the pile is in permafrost.

The permafrost table has been affected by warming from the southward shifting stream bed, cooling from the absence of snow under the bridge which facilitates deep frost penetration at the abutments, and warming from heat flow from ground water flow in the thaw bulb. It would have been very difficult to anticipate the current permafrost conditions and changes from those of 20 years ago when the bridge was designed and built.

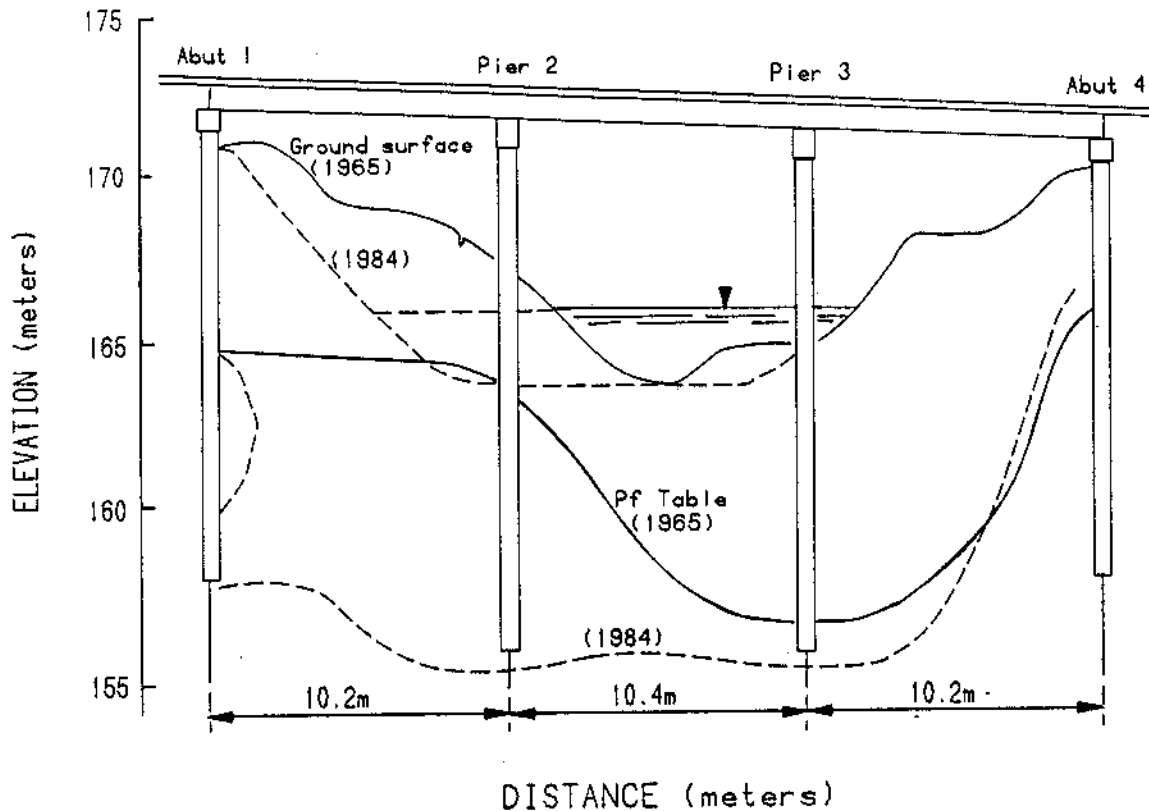
FIGURE 4: CROSS-SECTION OF GOLDSTREAM CREEK BRIDGE
SHOWING CHANGE IN PERMAFROST CONDITIONS

Pier 2 has experienced the most dramatic change in the depth to permafrost, with the permafrost table falling to below the pile tips (see Figure 4). The south side stream bank which was originally penetrated by Pier 2, has eroded badly with much of the erosion taking place during the 1967 flood. At present, the stream bed has widened to the south by approximately 16 ft (5 m) from it's location in 1965, causing the increased size of the thaw bulb beneath the stream. Progressive settlements as much as 1.2 in (3 cm) per year have occurred at Pier 2, in addition to minor frost heaving each winter. After settlements amounting to more than 6 in (15 cm) had occurred by 1974, creating an obvious dip in the bridge deck, repairs were made by raising and shimming the main girders. The large settlements occurring at Pier 2 are the result of losses of support and down-drag due to the thawing and consolidating permafrost around the piles.

The present permafrost condition at Pier 3 is very similar to Pier 2. Ground temperature data and probe surveys both indicate that the permafrost table progressively dropped from approximately 3 ft (1 m) above the pile tip to just below the pile tip. Pier 3 performed comparatively better than Pier 2 due to the fact that Pier 3 was driven in already-thawed soils. Piles 9, 10, 11, and 12 of Pier 3 penetrated the first 18 ft (5.5 m) of soil with relative ease with pile 2 plunging 18 ft (5.5 m) under the weight of the hammer and pile only. Pile driving records indicate very little resistance was encountered until the last 4 ft (1.2 m) of pile driving.

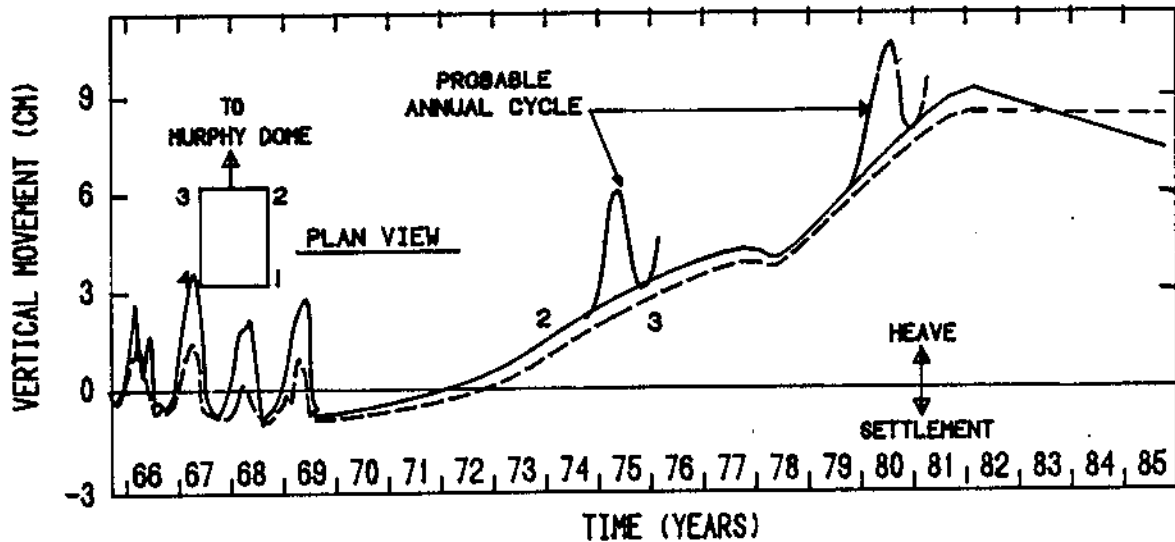
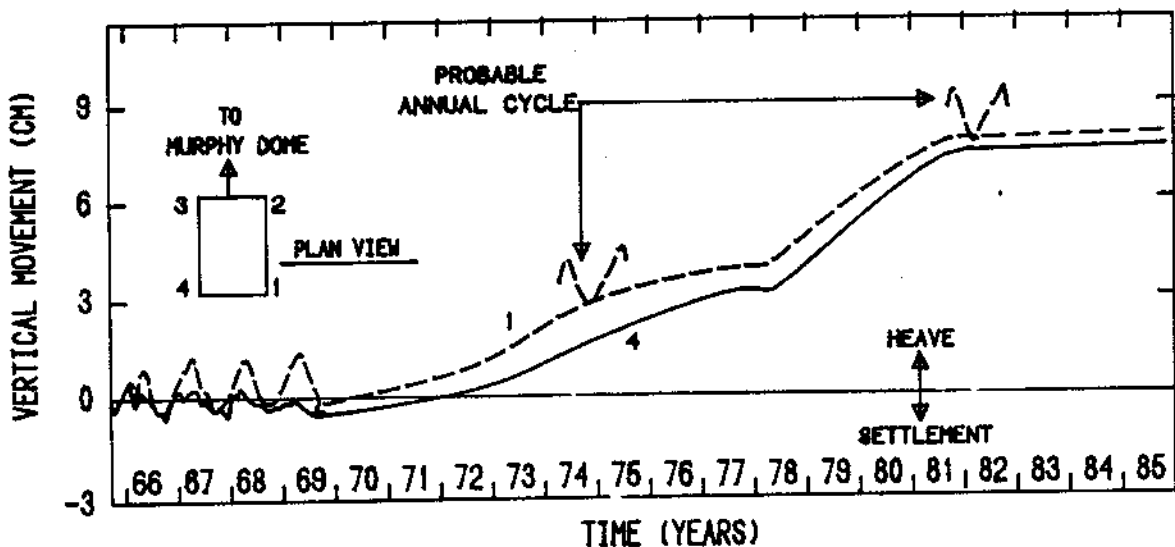
FIGURE 5: DISPLACEMENT WITH TIME MOOSE CREEK BRIDGE

Pile driving for the Moose Creek Bridge started 13 May, 1965. The Moose Creek Bridge is a single span bridge 49 ft (14.8 m) in length. The bridge piles are approximately 27 ft (8.2 m) long, driven into a sand and gravel stratum to the specified design tip elevation of 543 ft (165.5 m). Bedrock at the Moose Creek site was encountered at an elevation of approximately 533 ft (162.4 m). However, bearing in the sands and gravel was considered sufficient and there was thought to be adequate imbedment in permafrost to prevent frost heaving. The long-term elevation data shown in Figure 5 indicate a progressive annual heaving of the entire bridge deck

beginning in the early 1970's. It is apparent from the temperature data shown in Figure 6 that the loss of ad-freeze strength due to the thawing permafrost in the early 70's is responsible for the bridge heaving as much as 5 in (12 cm). The temperature data also indicate there was a small amount of thawing taking place from the surface and the majority of the thawing was due to lateral heat flow from ground water which expanded the thaw bulb beneath the stream. Beginning in the early 80's to the present, heaving of the bridge appears to have stopped with only a slight upward movement in the past four years. A possible explanation for the present stability of the bridge may be attributed to the eventual consolidation of the soil near the pile after thawing.

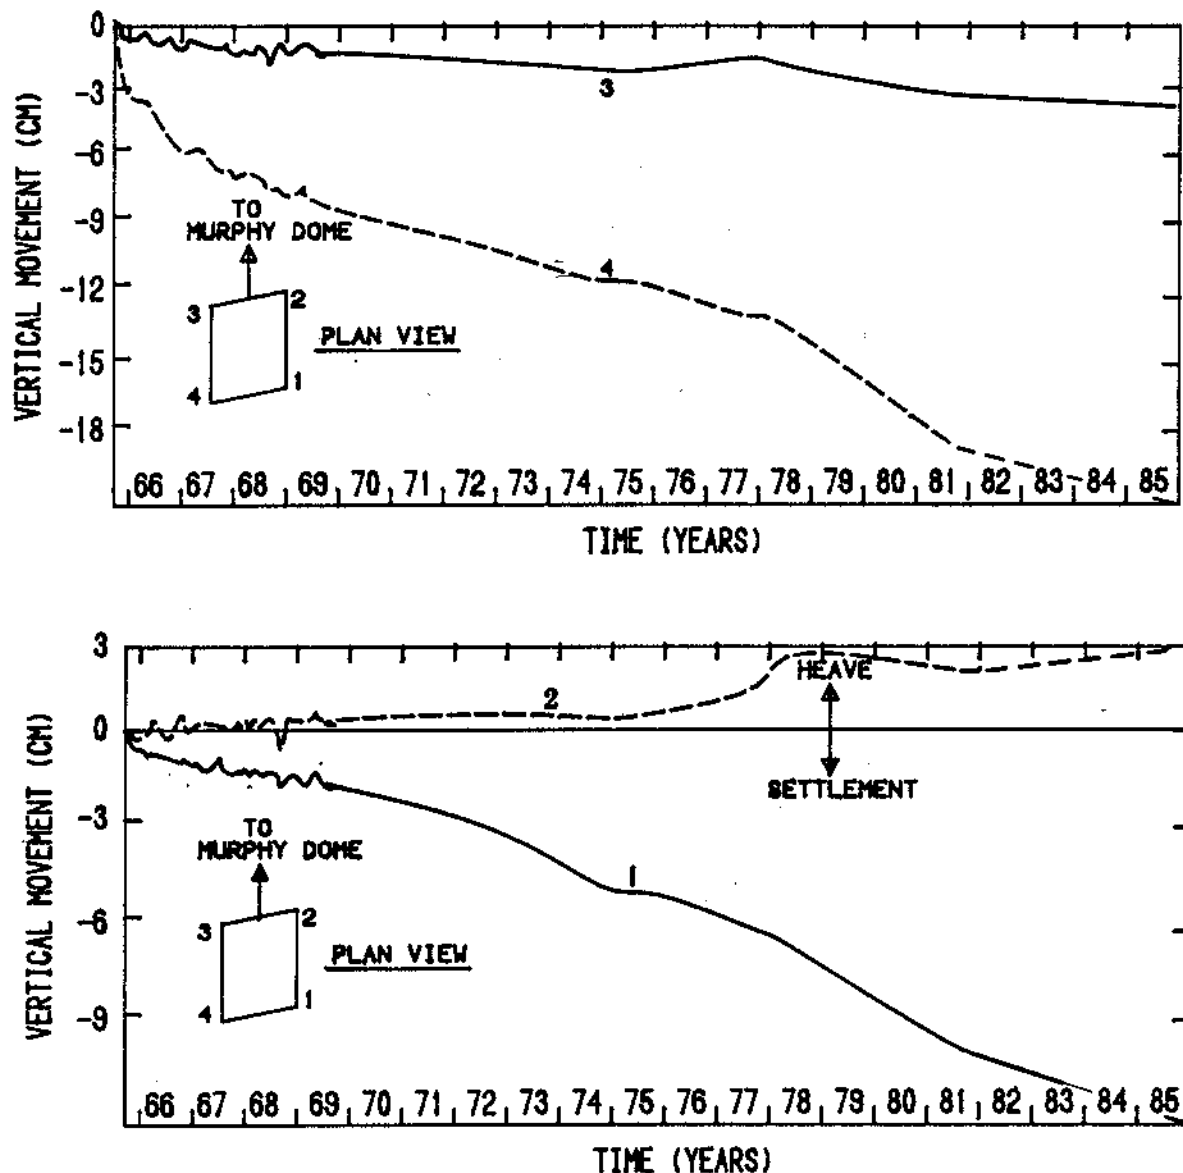
FIGURE 7: DISPLACEMENT WITH THE SPINACH CREEK BRIDGE

Pile driving for the Spinach Creek Bridge began on 25 March, 1965. The bridge is a single span 61 ft (18.5 m) long bridge skewed 60° to the centerline, allowing for the angle at which the stream confronts the road. The bridge foundation consists of eight 10 BP57 piles, all driven to a specified design tip elevation of 484.5 ft (147.6 m), with the exception of pile eight, which was driven to an elevation of 482 ft (146.8 m) in order to obtain the specified minimum bearing value of 45 tons as calculated by the Modified Engineering News Formula. There was no attempt to drive the piles to refusal even though bedrock was approximately at an elevation of 480 ft (146.3 m). Because of the shallow depth to which the piles were driven, frost heaving was a major design concern. For frost heave protection, piles were set in pre-augered 10 ft (3 m) deep holes, then cased and later filled with an oil-wax-soil mixture. Vertical movement data at the Spinach Creek Bridge indicate a wide range in motion (see Figure 7), with the bridge deck becoming diagonally warped as much as 9.5 in (24 cm). Abutment 1 (VM 1, and VM 4) has settled considerably in the past 20 years indicating the need to have driven the piles to bedrock which may be just a few inches below the pile tips. A marked increase in the rate of settlement

in the late 70's to the early 80's may be an indication of when the permafrost had completely thawed near the piles. As shown by Figure 8, the permafrost surrounding both instrumented abutment piles has progressively thawed entirely during the past 20 years. Unlike the Moose Creek Bridge, there is little evidence of frost heaving at Spinach Creek. Vertical movement point 2 is the only VM point which did not settle. This may be because VM 2 is located directly over the one pile driven to an elevation of 482 ft (146.8 m). There was also a marked increase in heave rate in the late 70's indicating the thawing of the permafrost and loss of heave resistance during that time period.
